PROCESS INCIDENT INVESTIGATION REPORT

Incident: Flash over in Transformer at Ammonia storage leading to fluctuation in GTG power.

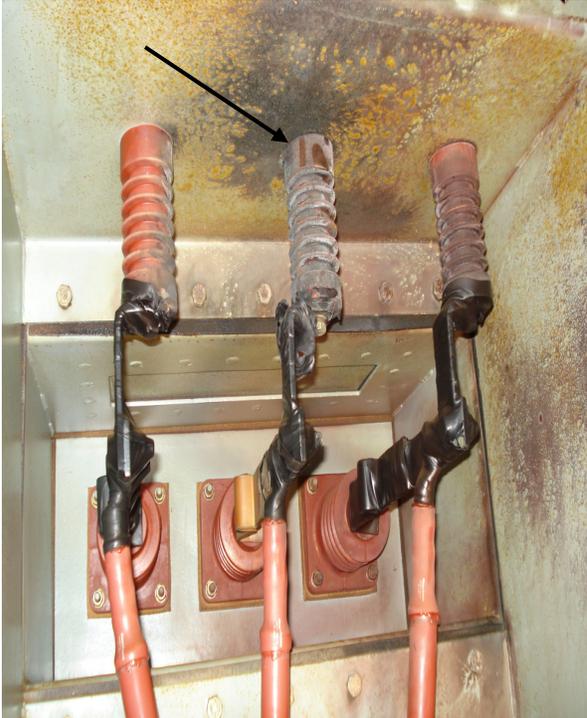
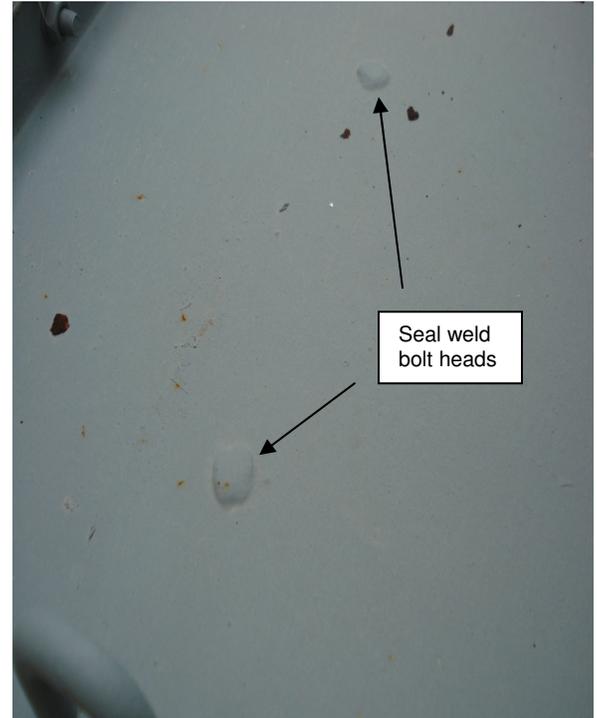
Ammonia storage transformer 11 KV termination side earth fault occurred through supporting insulators due to moisture ingress through mounting hex head bolt seal welding crack. This bolt is mounted through top from out side the terminal box (Please Refer the Figure below).

1. Supporting insulators mounting hex head bolts of all transformers welding will be checked by DP test in Shut down.
2. Rain protection shed over the uncovered transformers shall be provided (No. of such locations- 36).
