Mysterious magnetism in Process Air compressor train in KSFL

▪ Turbine make	:	M/s Siemens, Germany
▪ Type	:	NK 40/56-3
▪ Max. Speed	:	7690
▪		
▪ Rated speed	:	7323
▪ Critical speed	:	3600
▪ Rated output	:	12940 kW
▪ Inlet steam pressure	:	34.2 kg/cm ²
▪		
▪ Inlet steam temp:		420°C

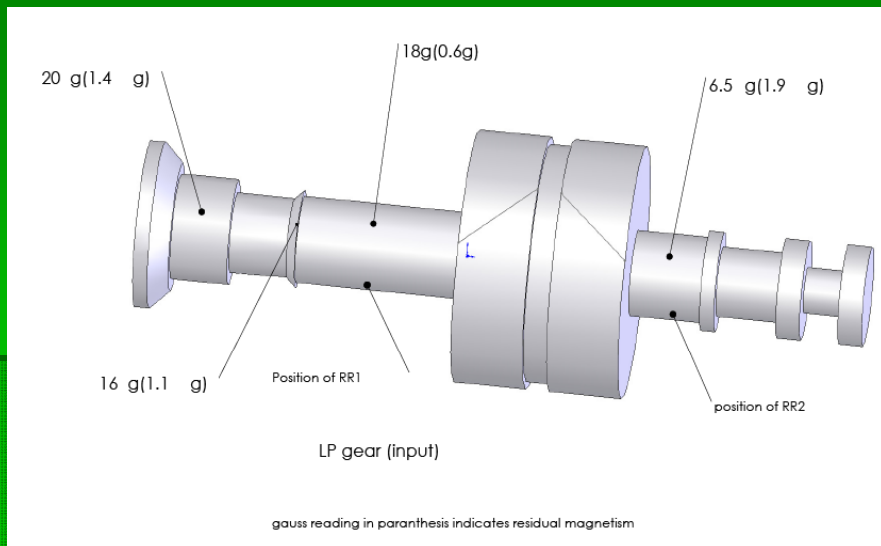
LP Gear Gauss values

- The photograph of damaged bearing (RR-1) shows clear indication on frosting
- The photograph of corresponding journal area of bearing (RR-1) shows clear indication on frosting
- The clearance increased from 0.20 to 0.47mm.
- Input shaft, casing of gear box found to be magnetized (18 gauss at journal portion)
- Continuous discharge of AC through earthing brush
- Rapid wear of earthing brush.

- All the casing (lower half) should be grounded with insulated copper cable. Upper half and lower half can be connected with a wire in all casing. This will ensure no accumulation of charges in stationery component.
- All components in PAC train should be demagnetized in the next opportunity. However to save down time, turbine casing and rotor can be left if the magnetization value at the coupling end is found within permissible range. The turbine and its casing was last de-gaussed in April 2009.
- Suction filters replaced with new filters (SPX make).
- All air traps installed in intercoolers made functional.

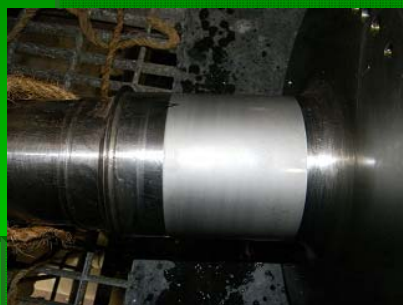
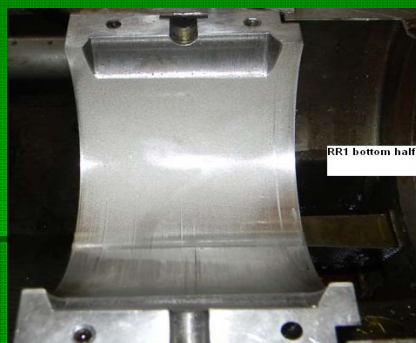
Photographs (frosting marks)

- The above inputs clearly indicate bearing getting worn out due to stray current discharging through bearing, which may be primarily due to electromagnetic current. The assumption is reinforced with the observation of high potential difference (pl ref: observation on 31.5.10) existing between rotor and earth.
- After degaussing of gear internal and casing on 14.5.10, there should not be any electromagnetic current discharging through bearing. Thus rising gap voltage after gear box overhauling which was observed on 24.05.10 is due to electrostatic activity on rotor (It is likely that charge is being carried from compressor or turbine end)
